Quinzième Congrès  
des Grands Barrages  
Lausanne, 1985

## EXPLORATION, INVESTIGATION AND TREATMENT OF SEEPAGE IN THE BASIN OF THE LA BOLERA DAM (\*)

J. DELGADO GARCIA

*Civil Engineer (Ph. D)*  
*Confederación Hidrográfica del Guadalquivir*

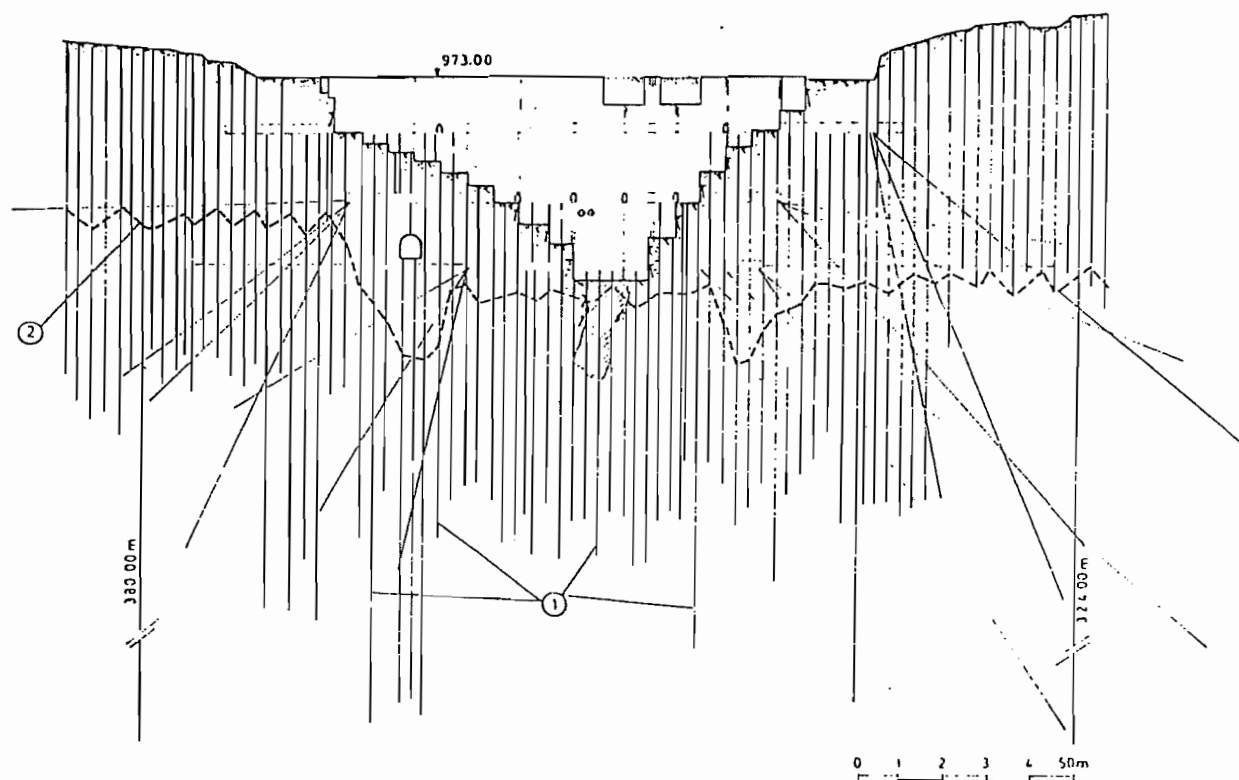
Fig. 6

Grout curtain  
*Voile d'injection*

The water table line (Fig. 6) shows a very irregular distribution always underneath the river level, with two very deep troughs in both dam abutments in the limestone zone. In the conglomerate zone, the water table levels had a more uniform distribution and were a little lower than the reservoir level.

In accordance with the recommendations of the geological report, grout curtains were executed in the sides and dam site (Fig. 6) in two phases. The first phase covered the dam site itself and 63 mm diameter bore-holes were sunk from the dam galleries. Bore-hole depth was of the order of 60 m at a 3 m spacing. Cement grout admission was highly variable from one bore-hole to another. The zone covered by these bore-holes virtually completely corresponds to the limestone formations and no karstic orifices were observed.

The second grouting phase consisted of widening the screen on both banks and increasing bore-hole density in the dam site zone to a 1.5 m spacing. Limestone continued to appear on the left-hand bank while the right-hand bank is constituted of conglomerates, as observed in Fig. 5. The cement grout

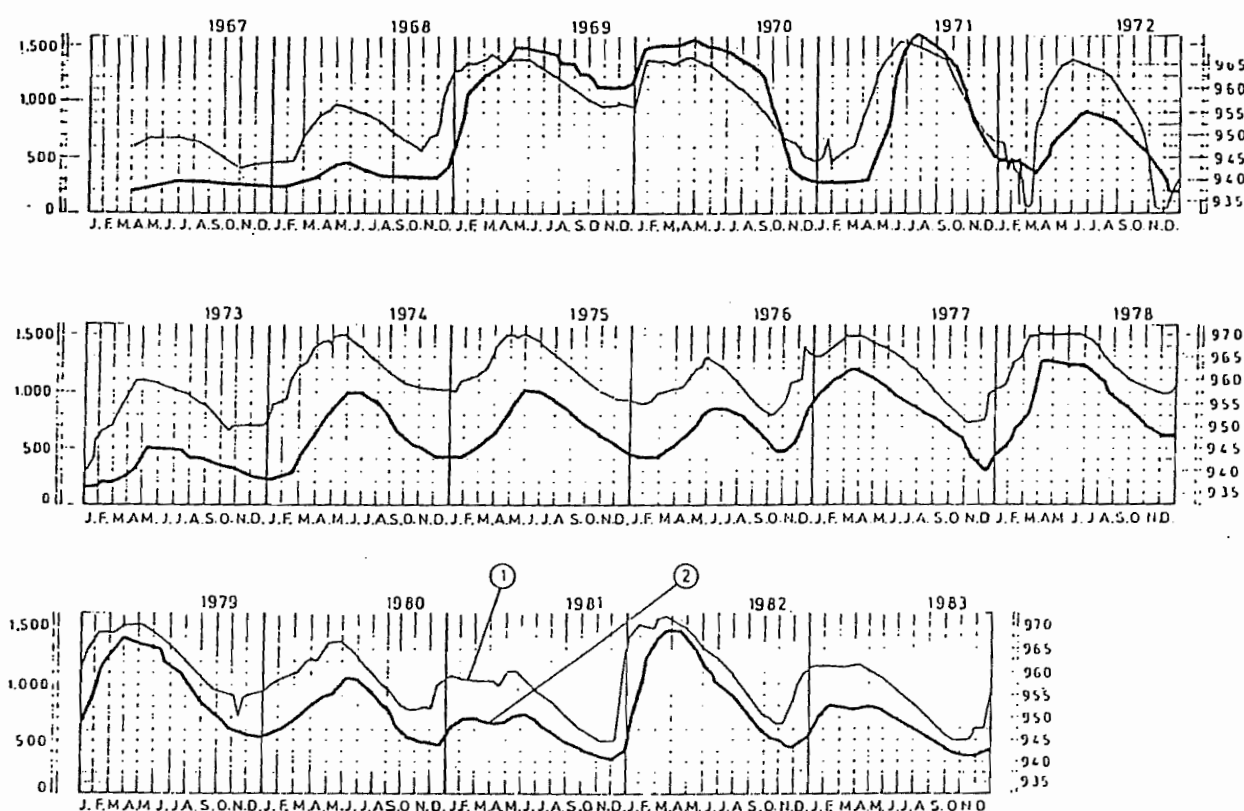
Fig. 7

Graphic, level of reservoir - Discharge of the spring  
 Graphique, niveau de la retenue - Débit de la source

On initiating the first partial filling of the reservoir in 1968, the source flow-rate only increased slightly. At the beginning of 1969 the reservoir was filled over in a short period of time, and was discharging through the spillway from January to May. The flow-rates of the Peralta source increased up to 1 400 l/s. As the reservoir level fell, so did the source flow-rate.

In 1970 the reservoir was again completely filled and discharged through the spillway from January to April and the source flow-rate again increased to (over in a short) a similar extent to the year before (Fig. 7 —reservoir level graph— source flowrates).

When the reservoir level rose again in the spring of 1971, the Peralta source flow-rate increased slightly but, on exceeding the level above the spillway lip with the gates closed (something that had not been done previously) the flow-rate of the Peralta source increased greatly and reached 1 600 l/s (as seen in the graph of Fig. 7).

In the graph of source flow rate —reservoir level (Fig. 7)— it can be seen that after carrying out the treatment the leakage in the years 1972, 1973, 1974, 1975, 1976 and 1977 decreased considerably despite the reservoir reaching its maximum level with gates in all of these years. The reduction in leakage can be estimated at 600 l/s which approximately represents one half of the water losses. From 1978 onwards the source flow-rates increase and, consequently, the leakage when the reservoir reaches the highest levels, but is, however, still small when the reservoir is at lower levels. This circumstance seems to indicate the opening of new drainage points in the high zone of the reservoir produced by the water removing the topsoils and rubble that were blocking them and a new drainage point system campaign is scheduled for this year.

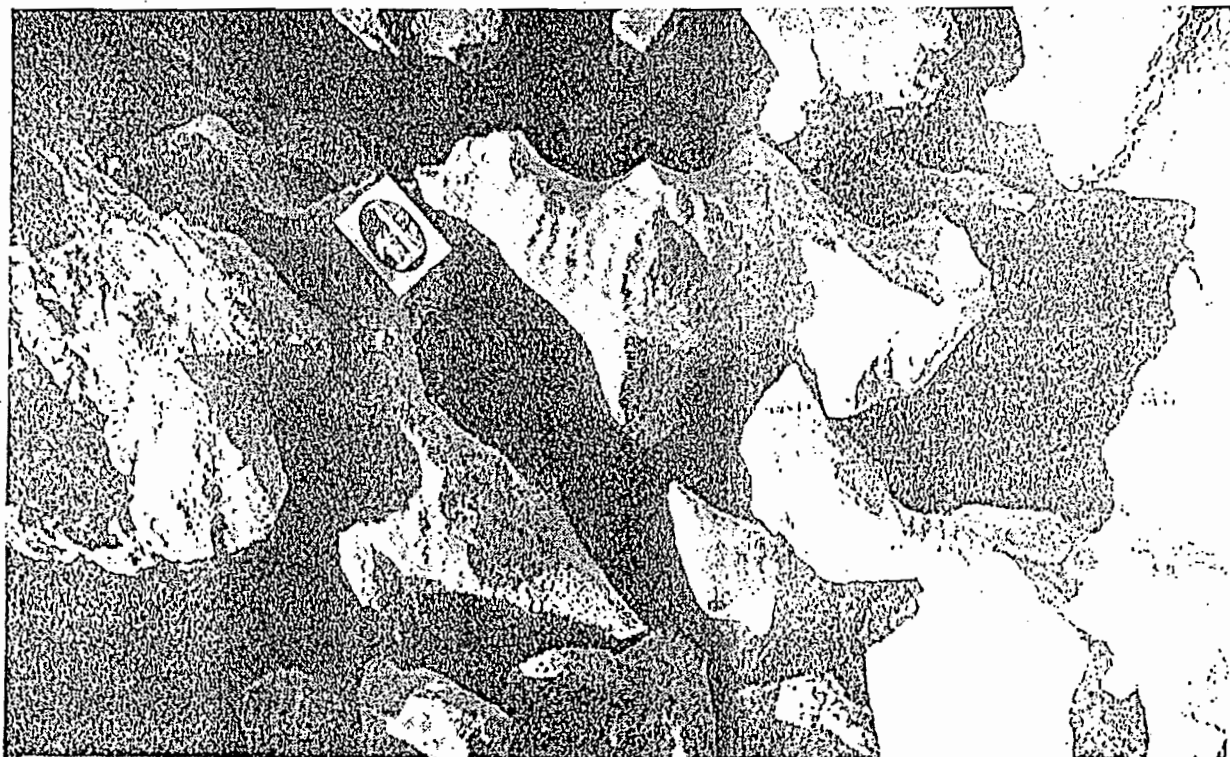
Fig. 8

Karstic zones  
*Zones karstiques*

Close to cavern no. 1 there is a strongly karstified zone covering 300 m lying between elevations 940 and — 971,40 (maximum reservoir level), where

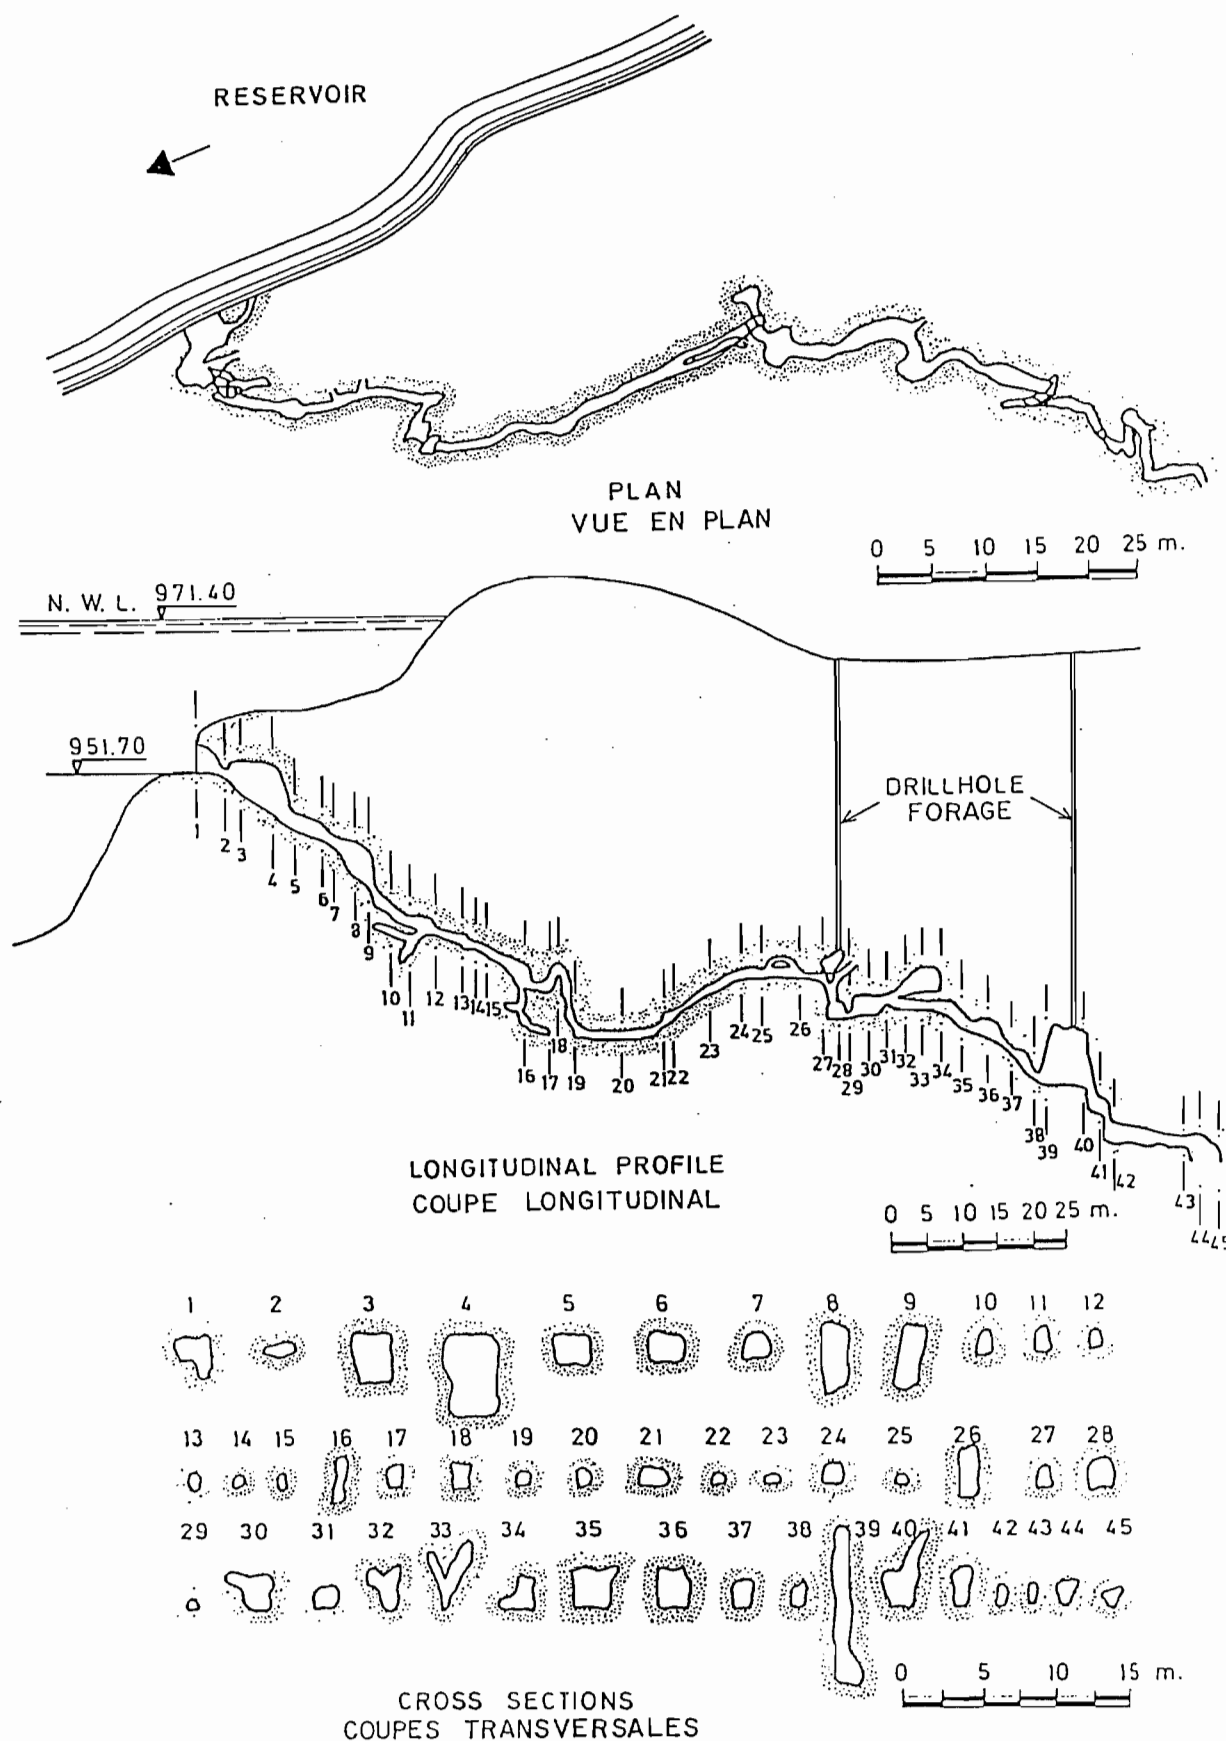
Fig. 10

Cavern no. 1, the plan, longitudinal profile and cross-sections of which are shown in Fig. 10, was inspected and explored over a length of 300 m with a

Cavern No. 1

level difference of 80 m. The exploration and survey of this cavern lasted 4 months, was a difficult and risky task given the narrowness of some zones of the duct through which a man could hardly crawl and given the need to remove rubble that was blocking some sections, the continuous ups and downs and the lack of ventilation, so that it could be considered as a speleological investigation (Fig. 10).

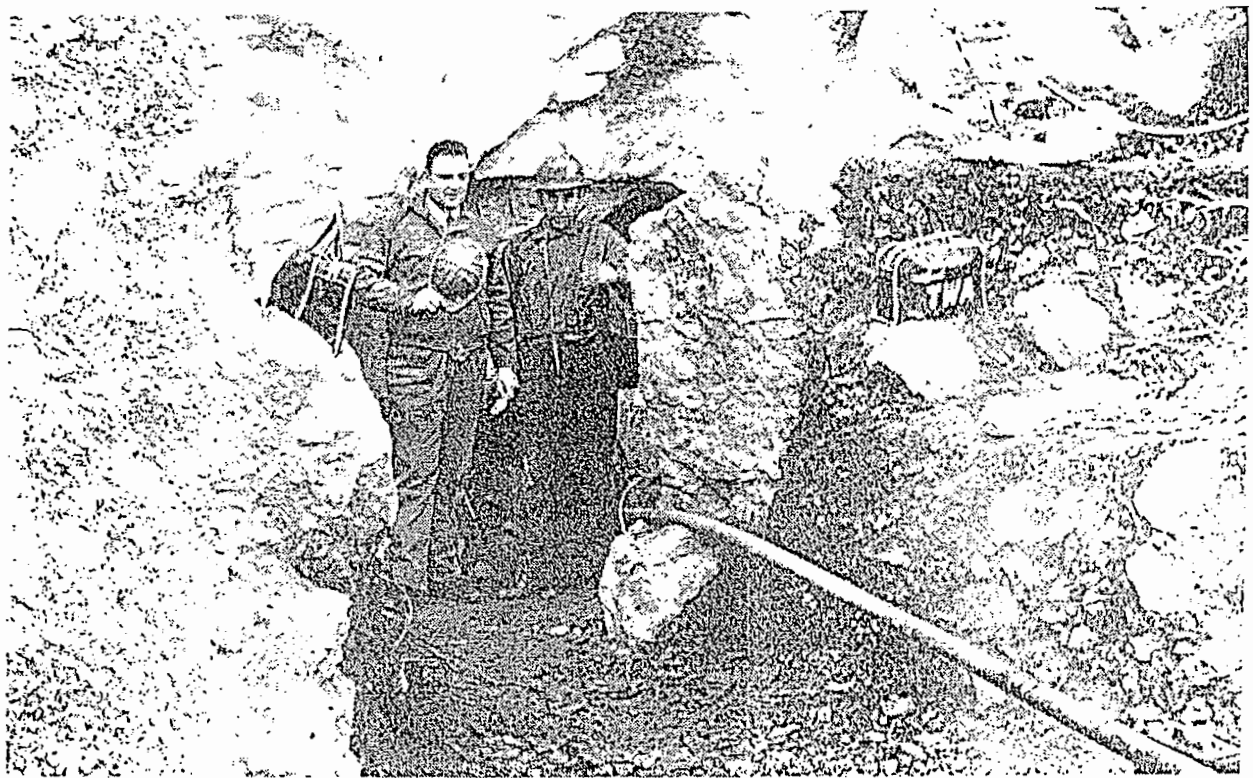
Fig. 11

Cavern No. 1 - Entrance  
*Caverne n° 1 - Entrée*

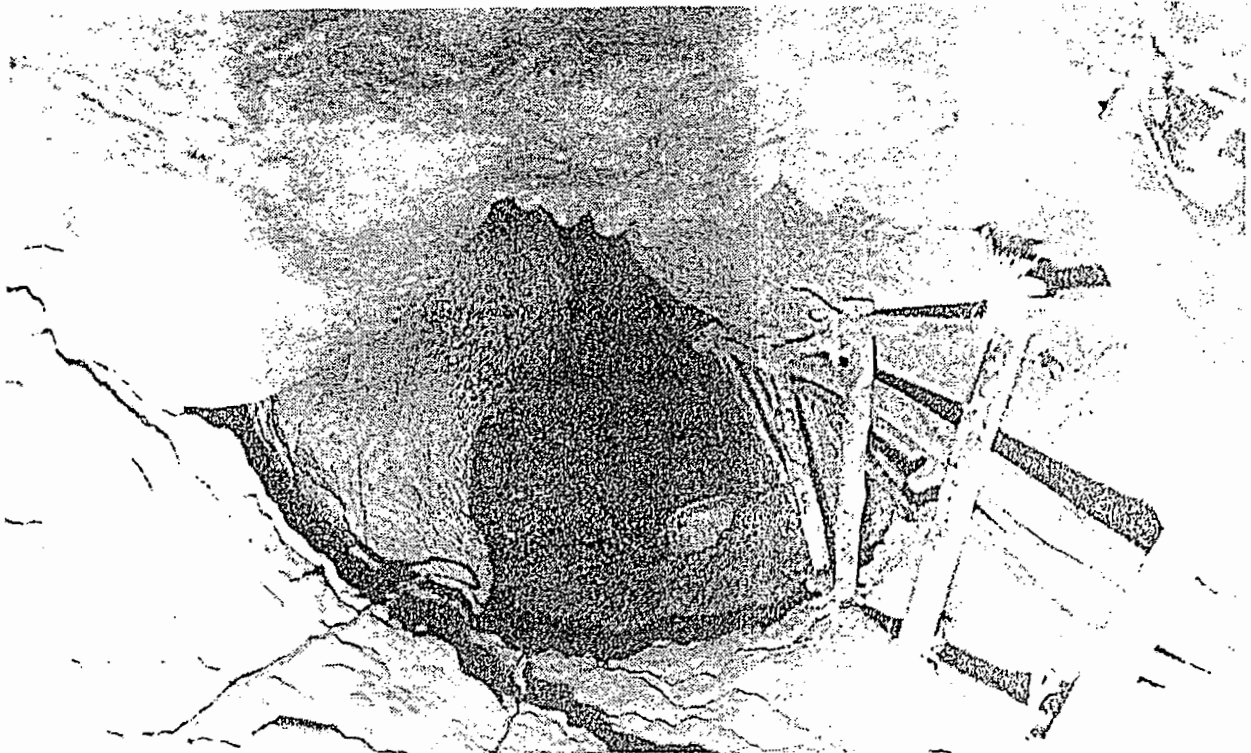
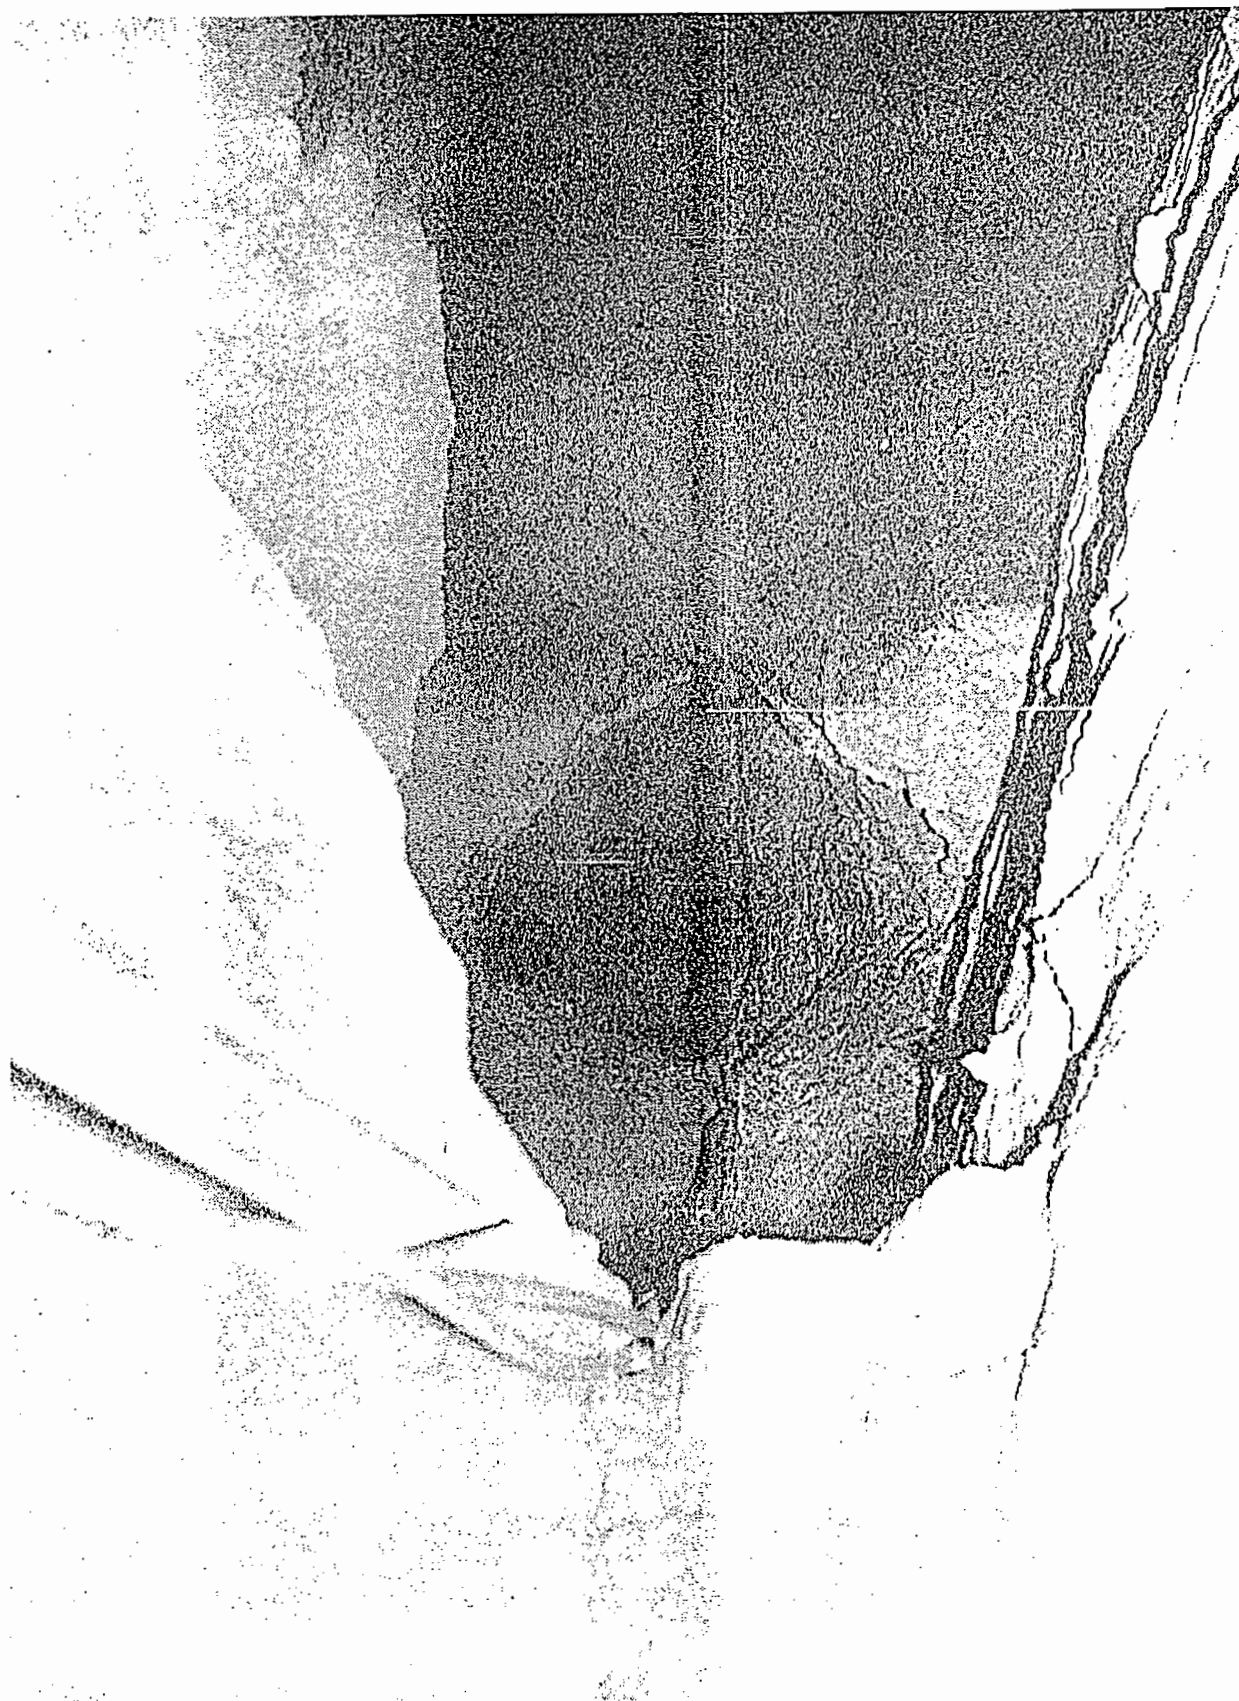
Cavern No. 1 - Interior  
*Caverne n° 1 - Intérieur*

Cavern No. 1 - Interior

This cavern comprises a typical karstic duct of water under pressure that corresponds to the juvenile phase of the karst formation with rounded shapes produced by the erosion of the duct perimeter as the water flows through under pressure.

Fig. 12 and 13 show the rounded shape of the ducts, without reconstruction phenomena and the existence of "terra rosa" decalcification clay alternating with other shapes, generally in fault or joint, of free translocation and limestone reconstruction phenomena.

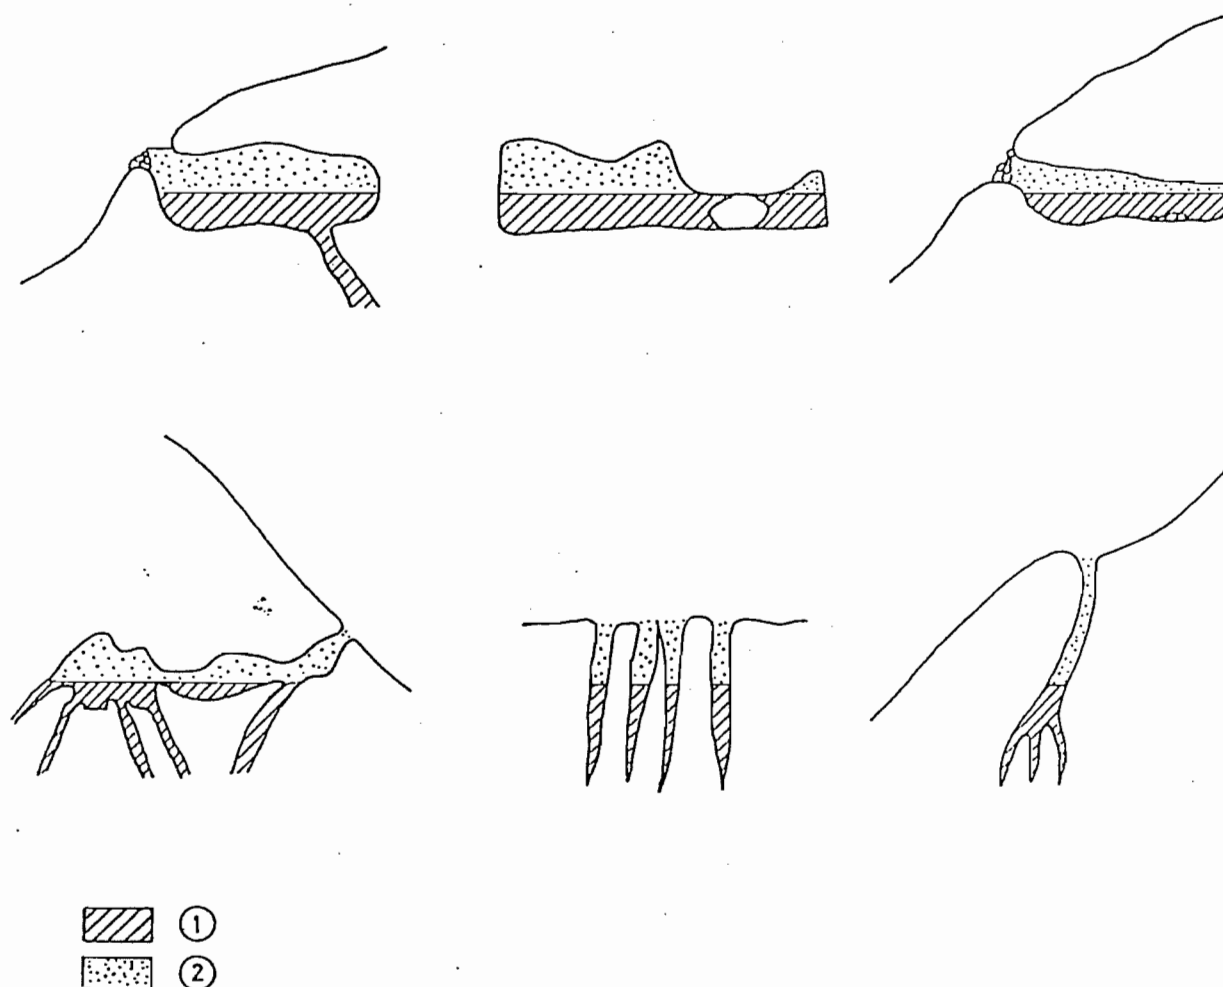
Fig. 14

| 1. Mortar | 1. <i>Mortier</i> | Other caverns - Treatment |

various caverns of relative importance (Fig. 14 and Fig. 15) were discovered and investigated to the point that entry is possible, together with small irregularly distributed drainage ducts. For the investigation and surveying of the small drainage points, the rock was cleaned, removing the topsoil and detritus and then testing absorption of the cracks and sink-holes in the limestone with a water hose in order to detect the zones water losses were taking place (Fig. 16).

The remaining visitable caverns (Fig. 14) were filled with the same system, introducing hoses through the entrance. Firstly, they were filled with cement grout to plug the smaller orifices, then with cement and very fine sand mortar and finally with clay grout. We consider it to be very important that the first fill is with cement or mortar grout in order to avoid them being uncovered by water action, with the clay only being to complete the sealing process when the main orifices are already covered.

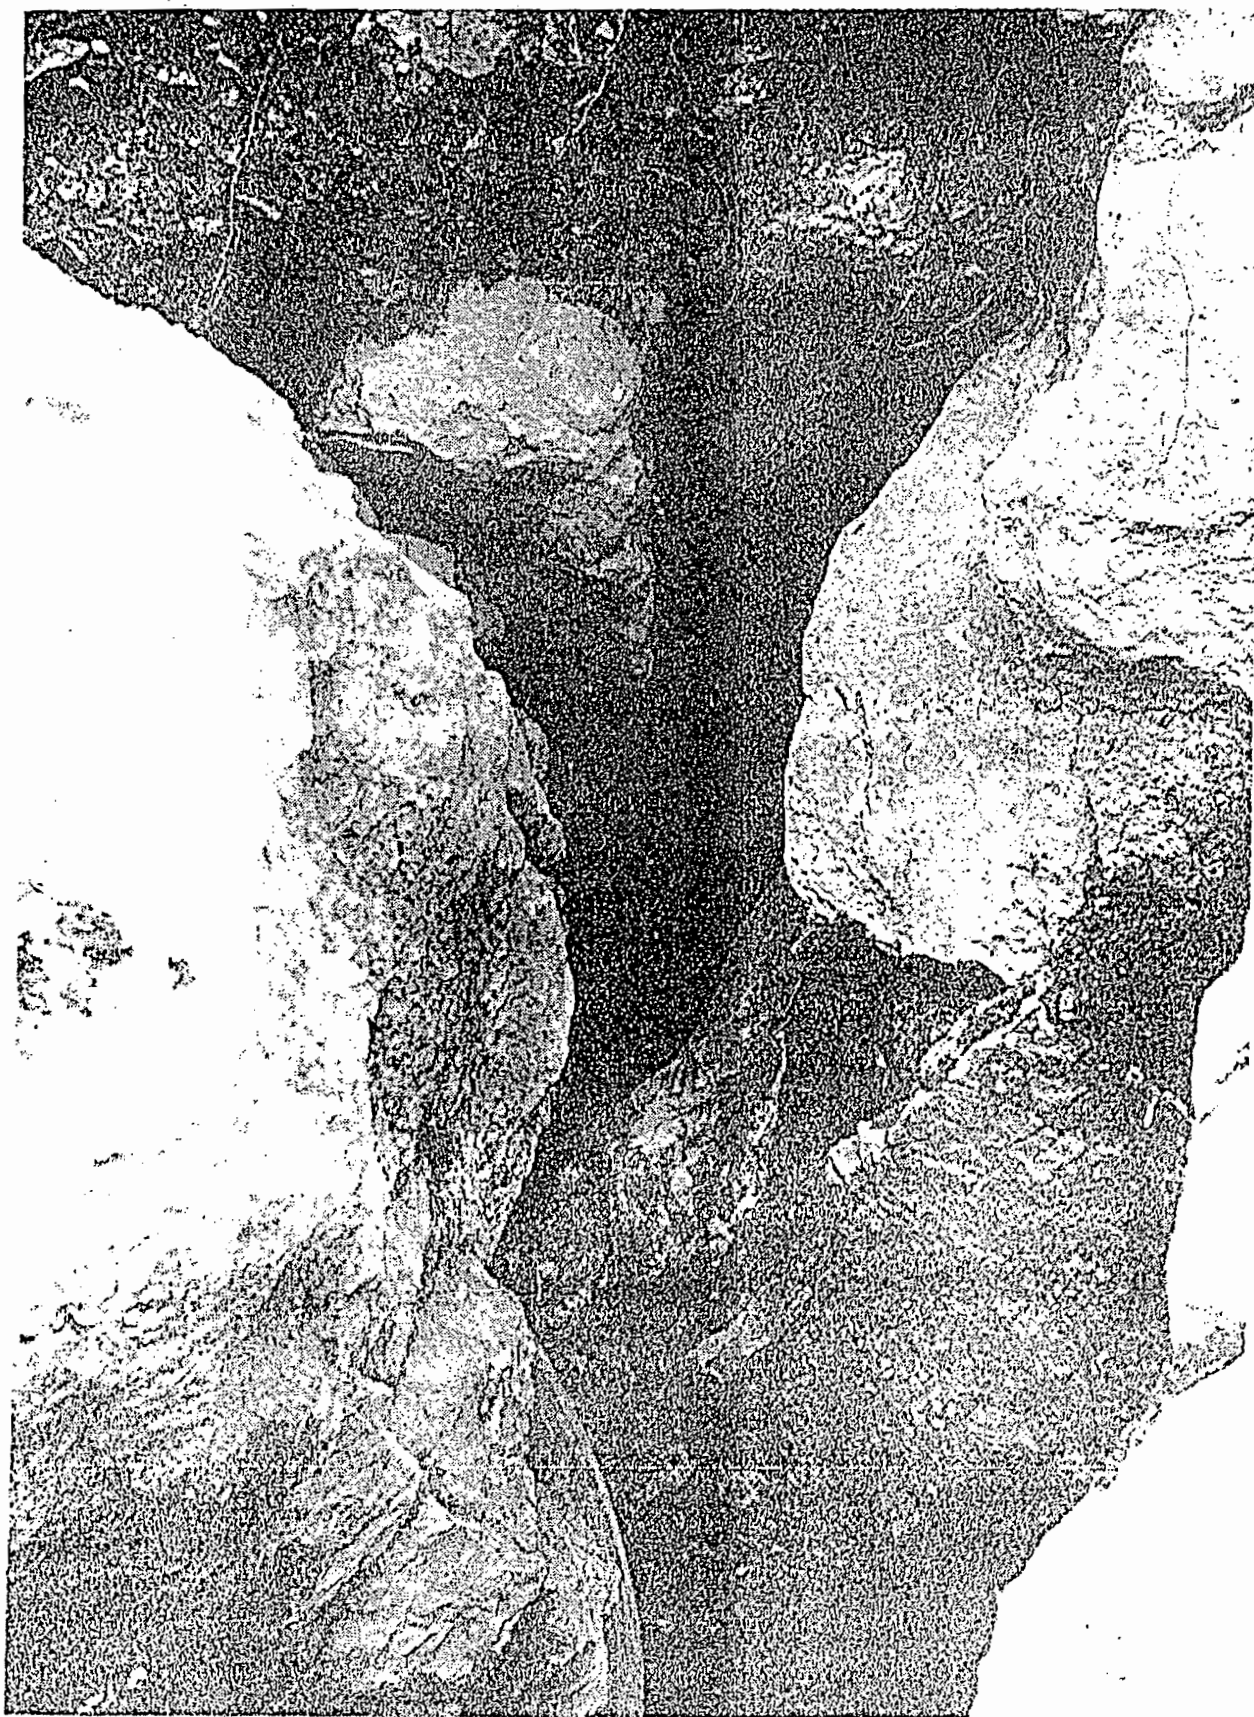
Fig. 15

Other cavern - Entrance  
*Autre caverne - Entrée*

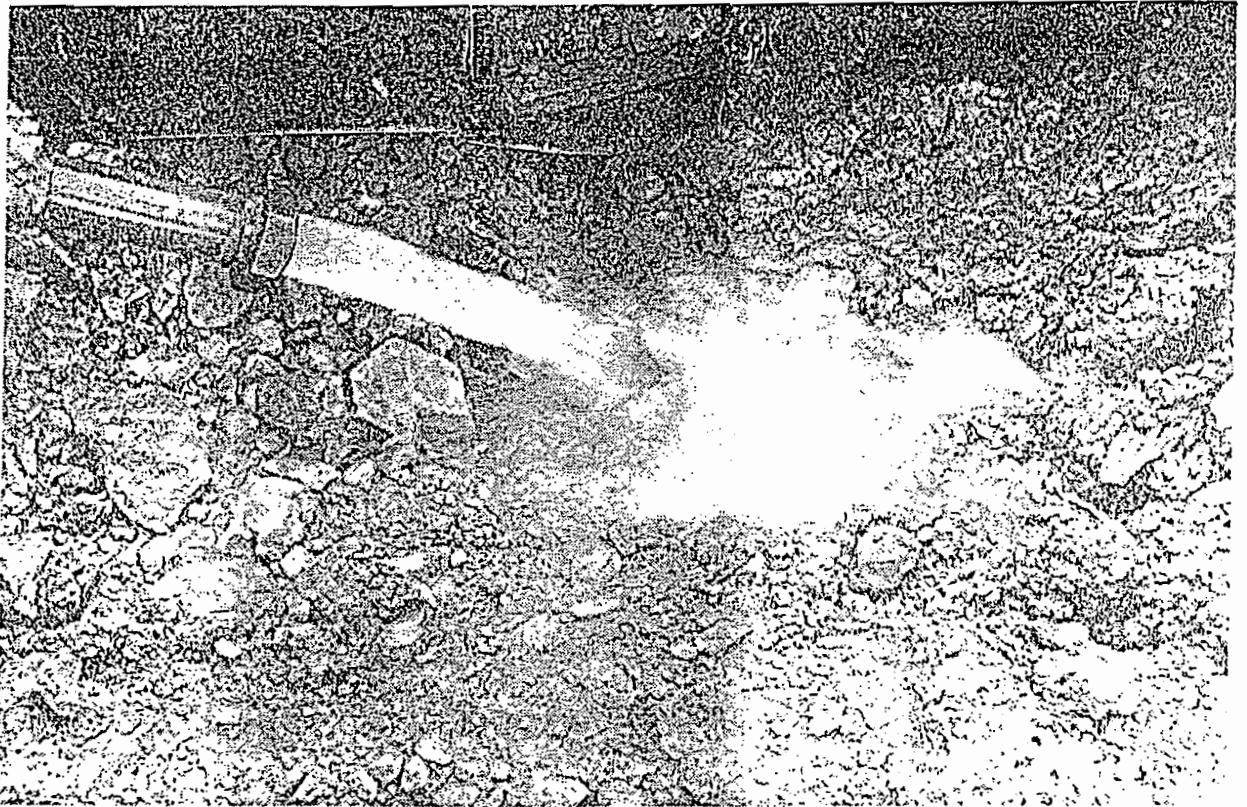
Fig. 16

Permeability test

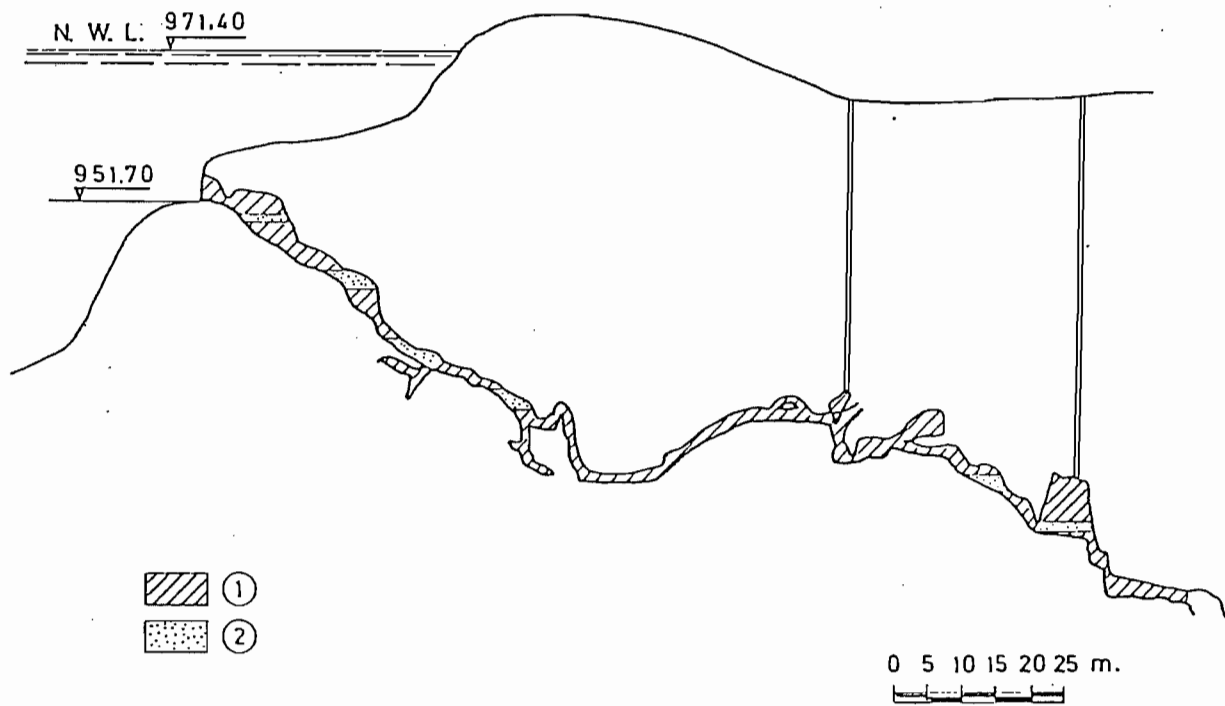
Fig. 17

| 1. Mortar | <i>1. Mortier</i> | Cavern No. 1 - Treatment |

Cavern no. 1, given its large size, is filled with sections of cement mortar in the narrow zones and clay in the wider zones (Fig. 17). Due to the existence of ducts in the form of a syphon, two bore-holes were sunk from the surface through which a flexible plastic hose was introduced through which the clay or cement and fine sand mortar grout was pumped. The first section of the duct was filled with flexible hose introduced through the entrance that was removed as the work advanced (Fig. 18).

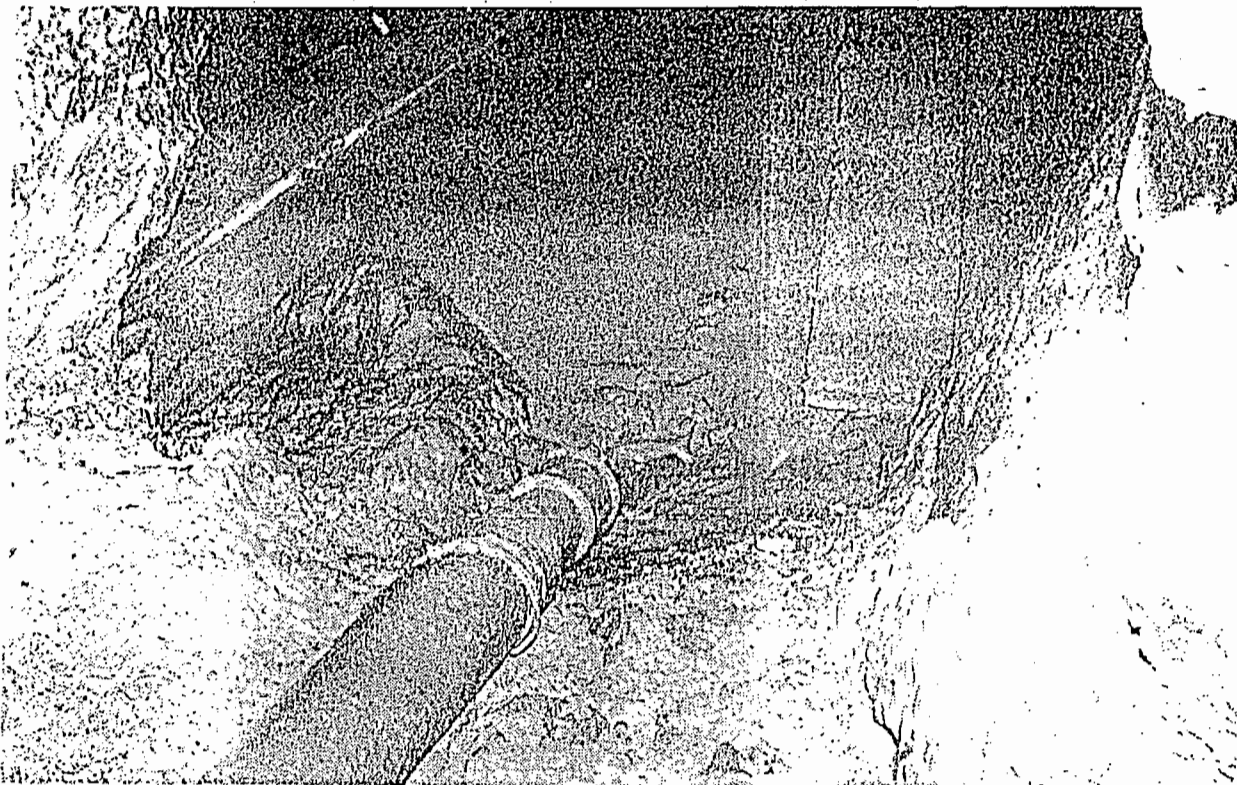
Fig. 18

Filling cavern with clay  
*Remplissage de la caverne avec argile*

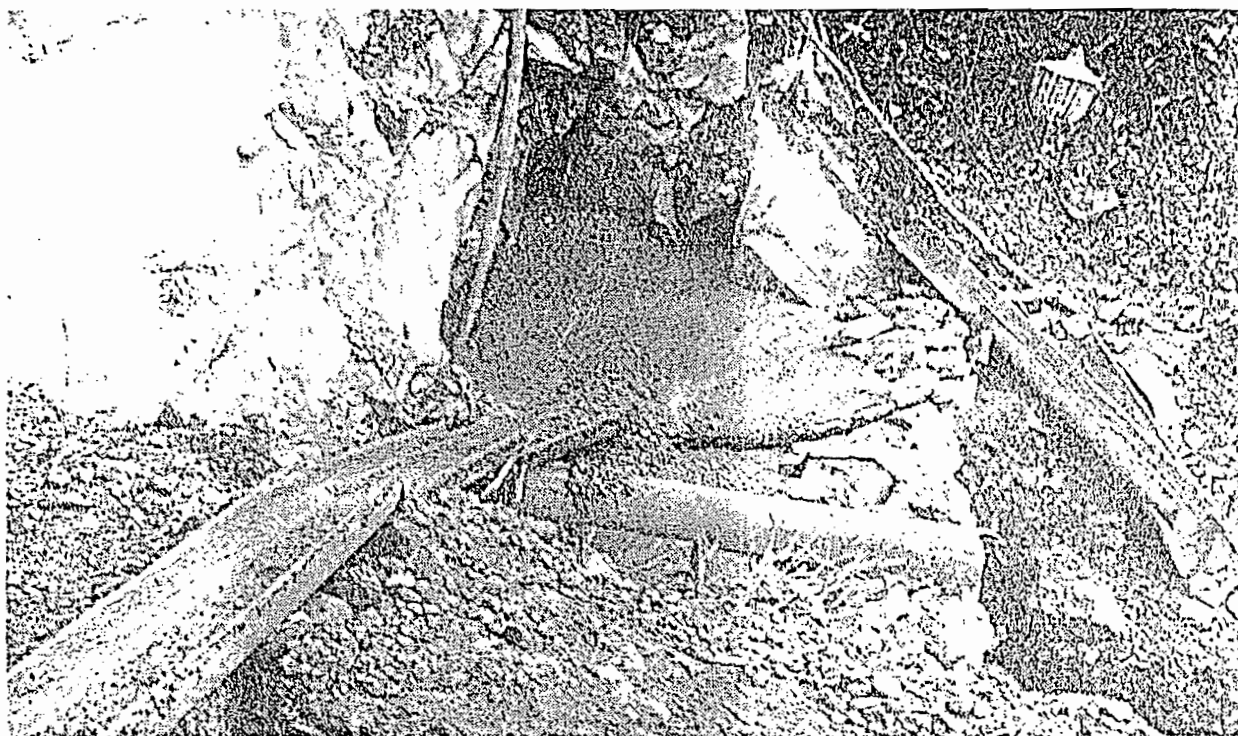
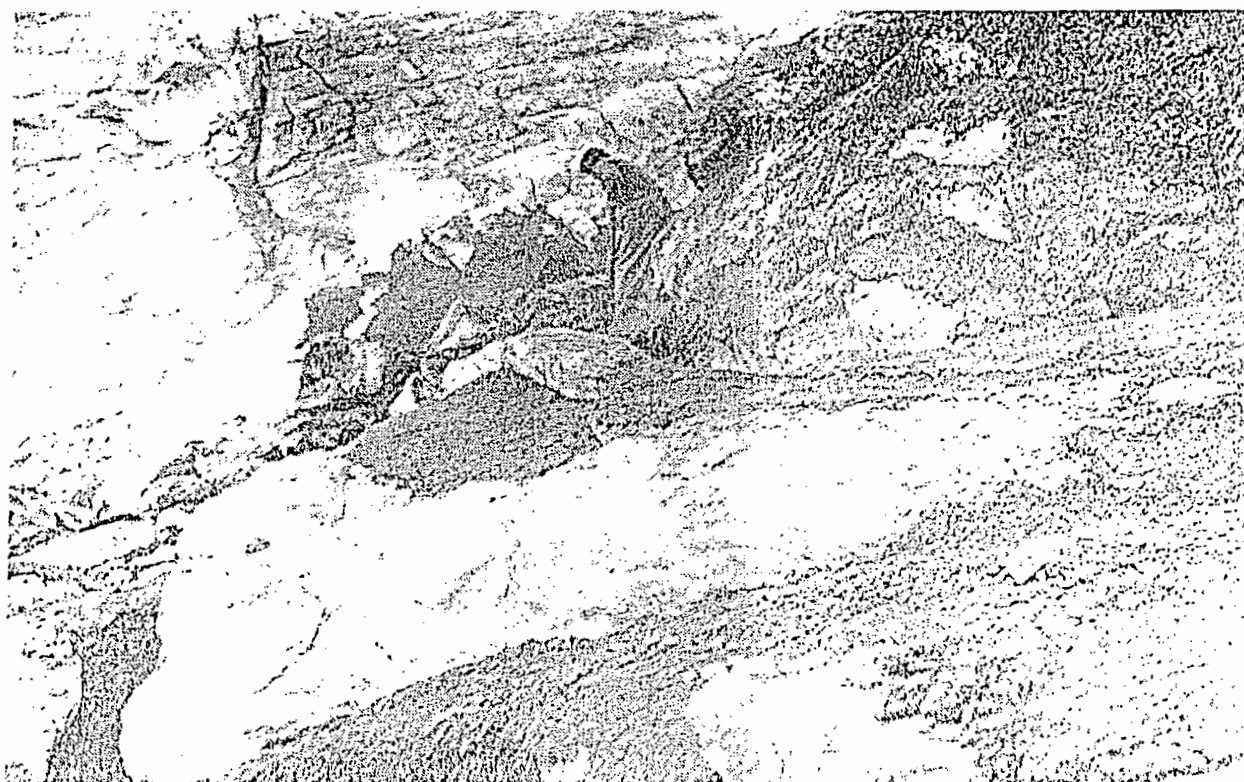
Superficial layer of concrete  
*Couche de béton en surface*

In order to complete the sealing off of the karstic zone after filling the drainage points found, surface layers of sealing concrete without coarse aggregates was executed to cover the whole zone suspected of containing karstic ducts. The concrete was mixed in an ordinary cement mixer and taken to the application zone through gutters and then spread by hand (Fig. 19 and 20).
