Quinzième Congrès  
des Grands Barrages  
Lausanne, 1985

## EXPLORATION, INVESTIGATION AND TREATMENT OF SEEPAGE IN THE BASIN OF THE LA BOLERA DAM (\*)

J. DELGADO GARCIA

*Civil Engineer (Ph. D)*  
*Confederación Hidrográfica del Guadalquivir*

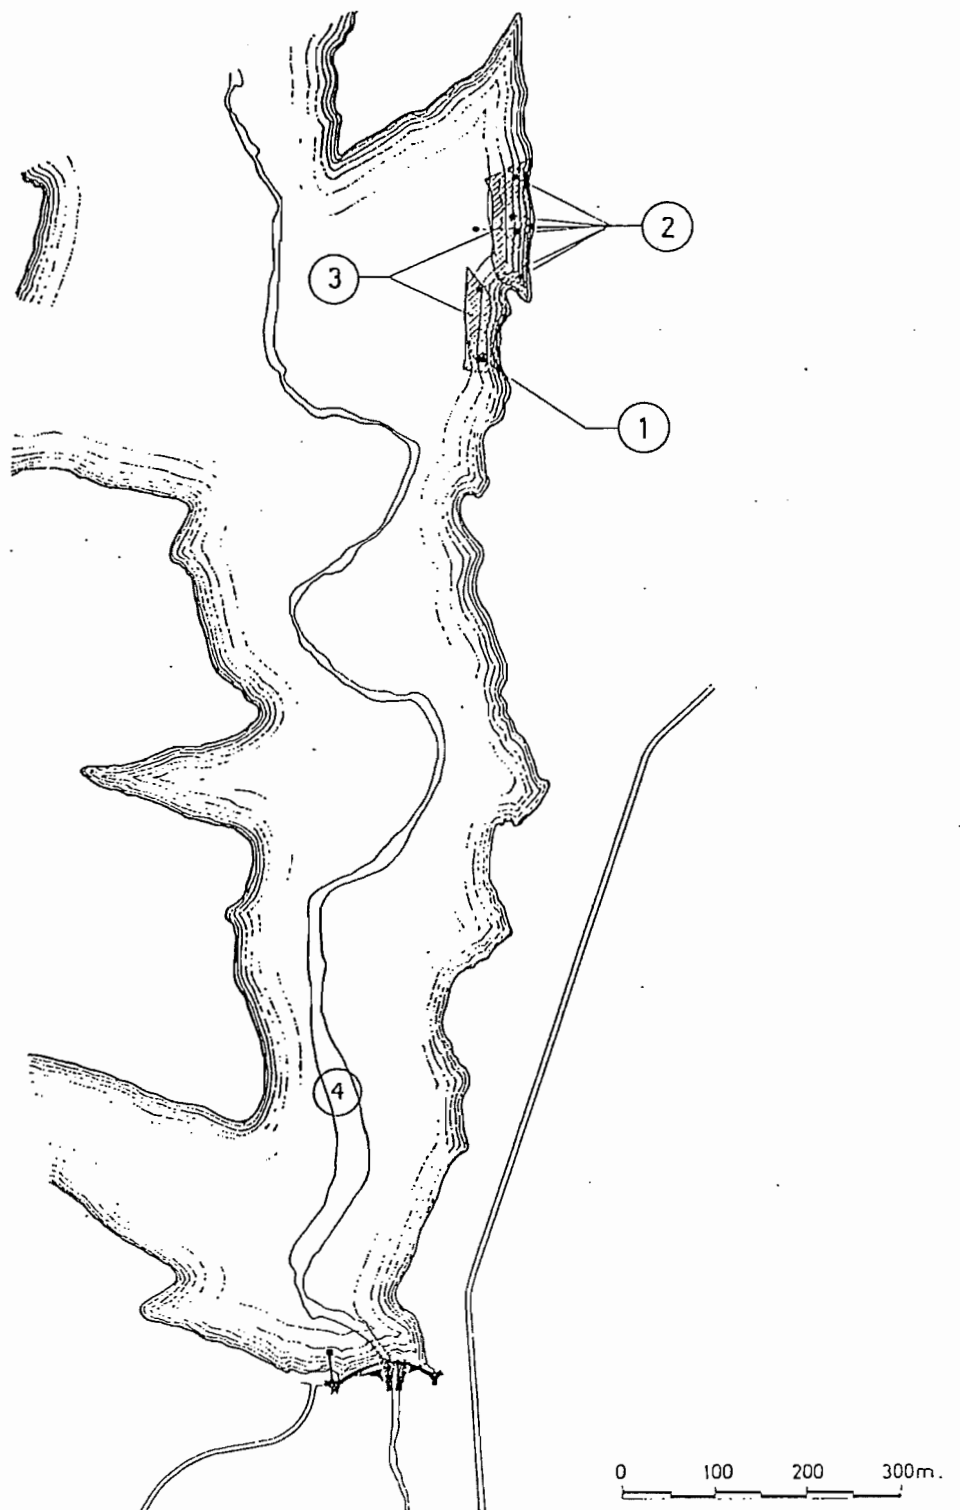
La Bolera dam, reservoir map  
*Barrage de La Bolera. Plan du réservoir*

- 1. Cavern No. 1
- 2. Other caverns
- 3. Karstic
- 4. Guadalentín river

As the level fell, the reservoir basin was carefully inspected, especially the limestone zone, with the result that a cavern of  $1,0 \times 0,5$  m was found at elevation 951,70 where, according to our calculations, some 500 l/s were leaking out.

Fig. 1 and 4 indicate the karstic limestone zone of the basin, located 1,5 km upstream of the dam and the location of the main cavern found is marked on Fig. 3 which we denominate cavern no. 1, together with that of other drainage points close to it (Fig. 8 and 9).

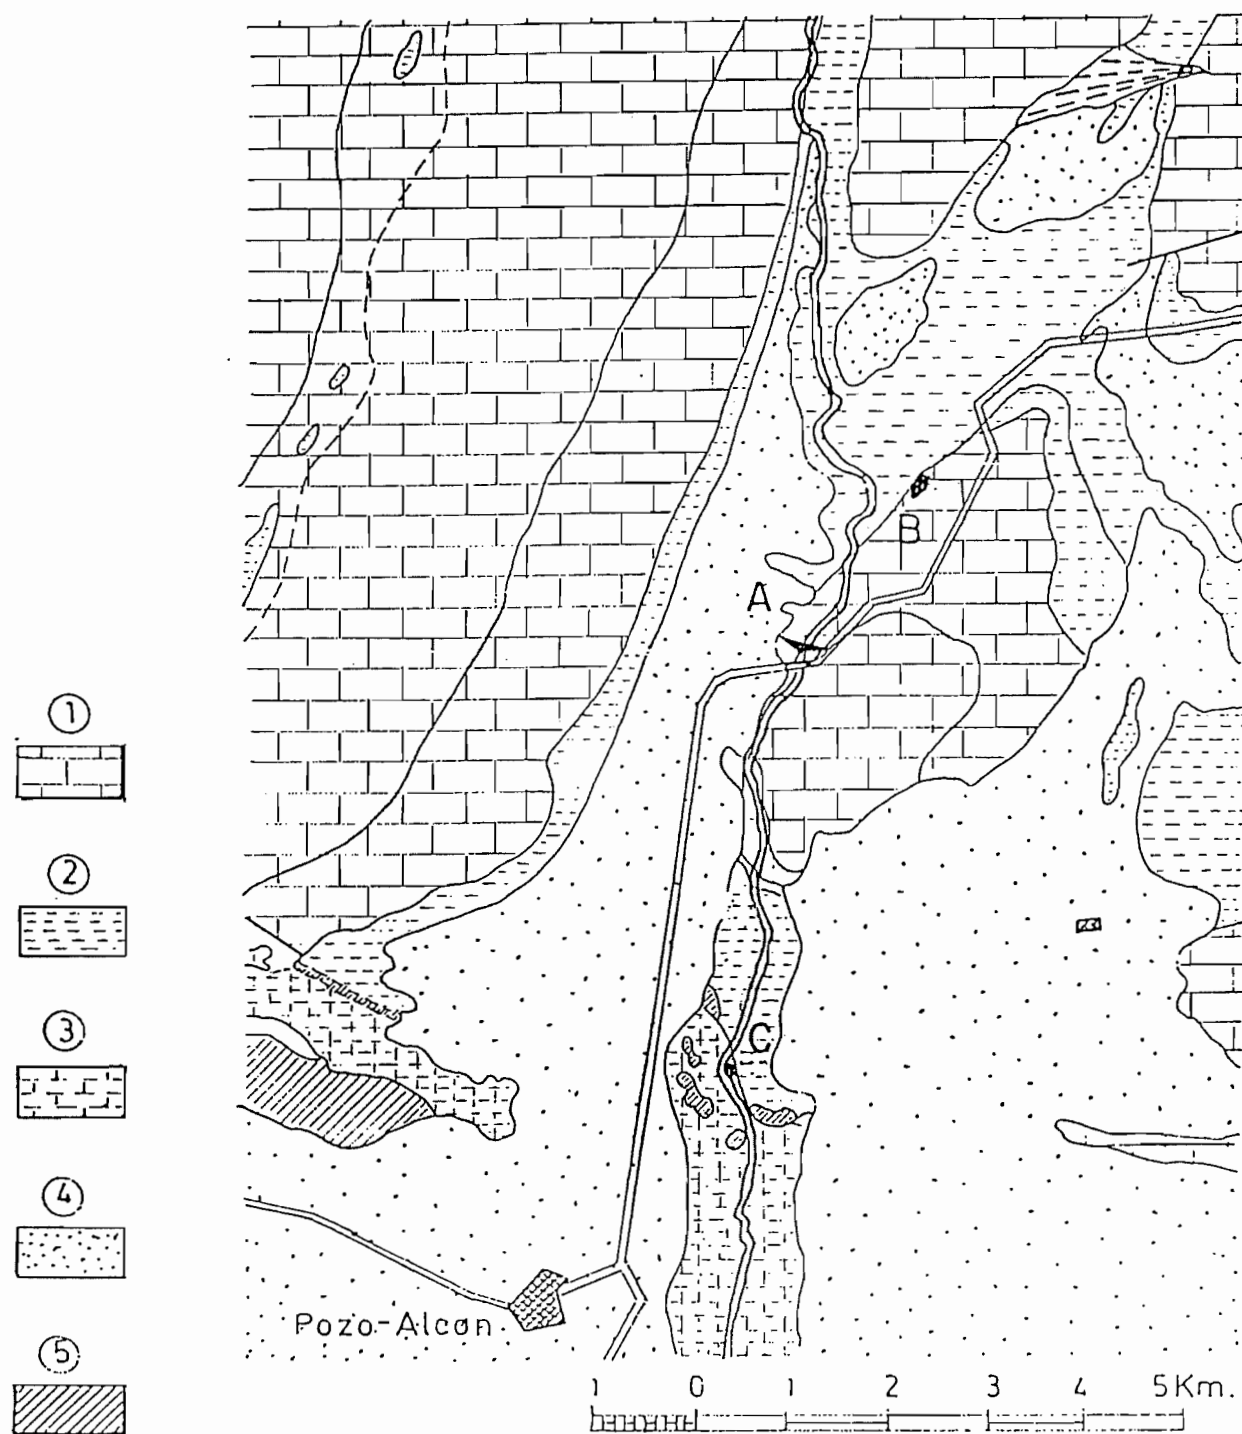
Fig. 4

Geological map  
Carte géologique

triassic (Keuper). Over the last 2 km these limestones are covered in the upper of the valley by cocene marl (Fig. 4).

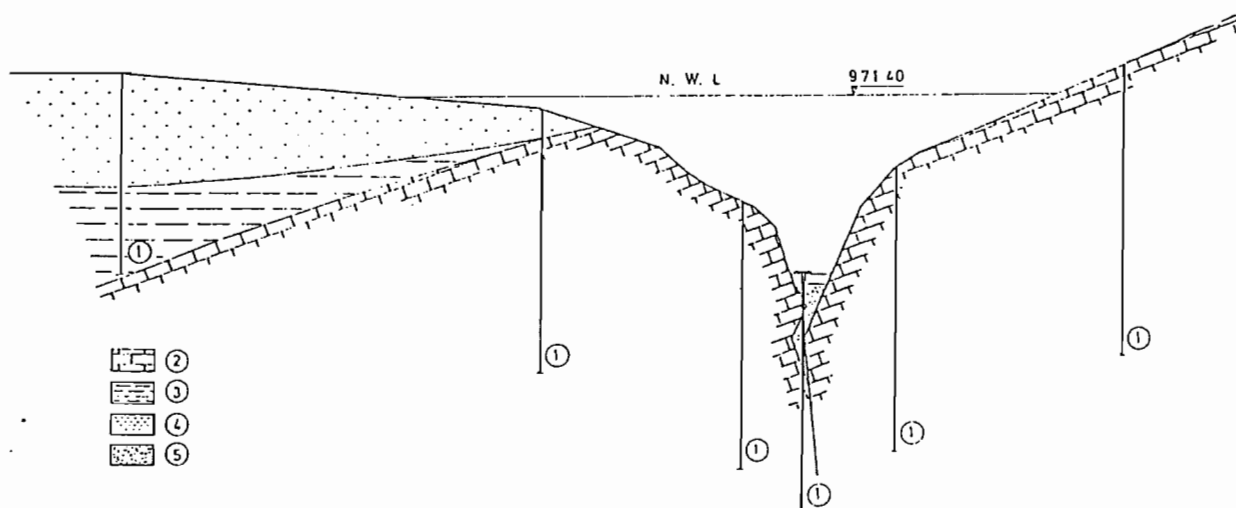
Fig. 5

In general terms, the geological structure of the dam site comprise a cretaceous limestone dome that is tangentially cut by the river bed. Above this limestone and concordant with it are the cocene marls on the right bank, with a horizontal conglomerate attributable to the old quaternary crowning them (Fig. 4 and 5).

Geological section of La Bolera Dam site  
*Coupe géologique de l'emplacement du barrage de La Boléra*

The second grouting phase consisted of widening the screen on both banks and increasing bore-hole density in the dam site zone to a 1.5 m spacing. Limestone continued to appear on the left-hand bank while the right-hand bank is constituted of conglomerates, as observed in Fig. 5. The cement grout
